Inspection Report

Property Address:
12345 SPECIAL DRIVE
SOMEWHERE ARIZONA 85000

Entire Valley Home Inspections, LLC

Date: 11/22/2019	Time: 12:00 PM	Report ID: 11-22-2019A-FM
Property: 12345 SPECIAL DRIVE SOMEWHERE ARIZONA 85000	Customer: SAMPLE REPORT	Real Estate Professional: Internet Search

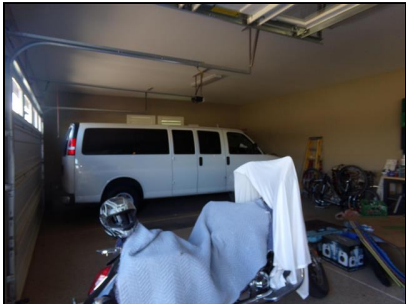
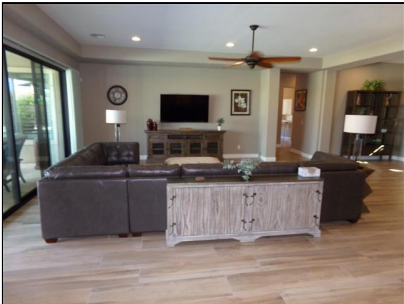
Home/garage has occupant belongings and furnishings in place making some areas inaccessible thus making it difficult and improper to efficiently inspect some areas of the structure. (M) (CS)

1.0 Item 1(Picture) Occupant Belongings

1.0 Item 2(Picture) Occupant Belongings

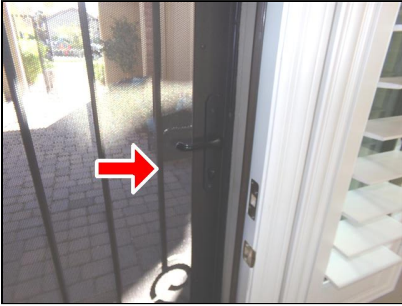
2.1 Item 1(Picture) Key Operated dead bolt

2.1 Exterior door have key operated inside deadbolt locks thus creating a possible safety aspect in the event an emergency exit or possible fire. Recommend replacing with a thumb turn type deadbolt (SA) (RR)

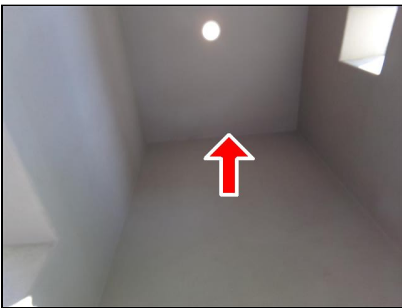
2.3 Item 1(Picture) Damaged, peeling drywall

2.3 Damages at exterior porch drywall ceiling. Repair drywall surfaces and textures and paint locations as necessary. (RR)

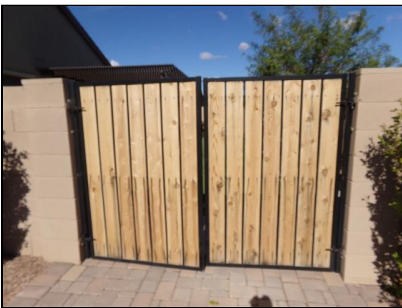
Re-apply wood stain/wood sealer to fence gate. The original application has faded and the wood is currently bare and susceptible to wood damage because of lack of paint/wood sealer. (RR)

2.7 Item 1(Picture) Re-seal and lubricate Fence Gates

2.7 Lubricate fence gates. Fences and gates are outside of our scope of inspection. Recommend monitoring fences and gates and repairing as needed. (RR) (M)

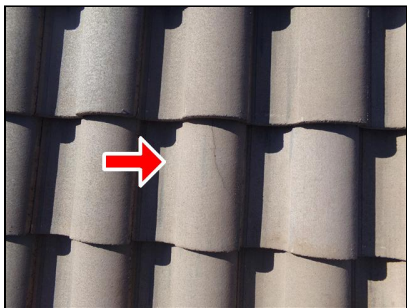
3.0 Item 7(Picture) Cracked Tile - Above Garage

Cracked roof tile at above garage. Have tiles in question either sealed with roofing cement or replace in order to prevent water damage and intrusion. (RR) (CE)

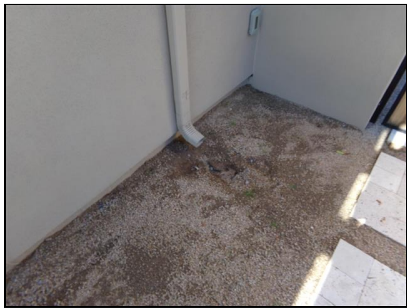
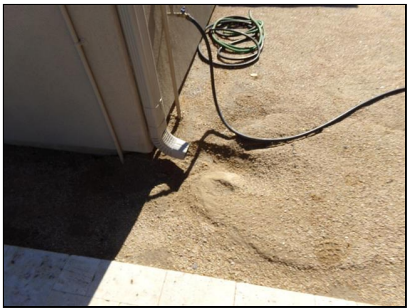
3.4 Item 1(Picture) Splash Guard Needed 1

3.4 Item 2(Picture) Splash Guard Needed 1

3.4 The downspouts need splash-blocks in order to prevent soil erosion and undermining of the foundation. (RR)

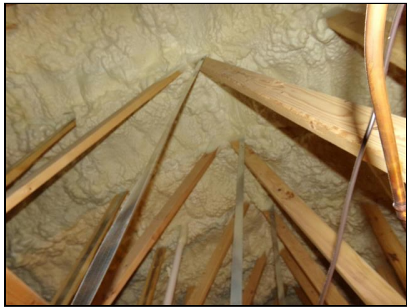
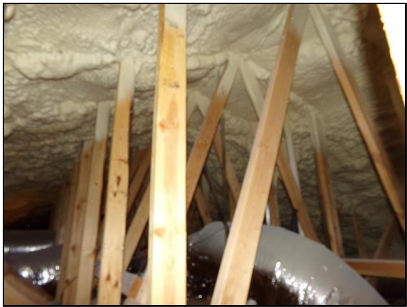
3.7 Polyurethane Foam was applied at the underside of roof sheathing in attic. As a result, water stains and possible water leaks can not be properly observed. (M)

3.7 Item 1(Picture) Polyurethane Foam - Attic 1

3.7 Item 2(Picture) Polyurethane Foam - Attic 2

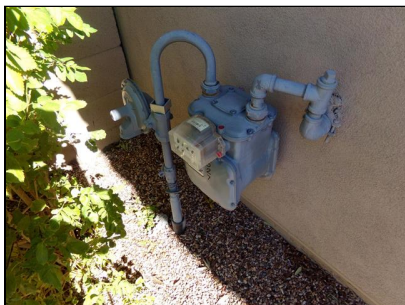
5.6 Item 1(Picture) Main Gas Valve and Meter

5.6 For safety purposes monitor gas lines for leaks. If you detect any suspicious odor indicating any possible gas leaks, immediately notify the gas company and the appropriate qualified licensed contractor for further evaluation and repairs. Underground and exterior gas and fuel lines are outside our scope of inspection. (CE) (M)

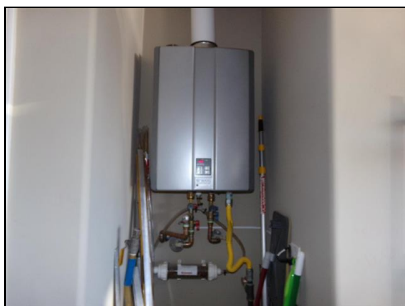
5.7 A Rinnai Tankless hot water heater is presently installed in the garage. The heater appeared to be in proper working order at the time of inspection. Consult the seller and manufacturer for proper maintenance and operation. (CS) CE)

5.7 Item 1(Picture) Rinnai Tankless Water Systter

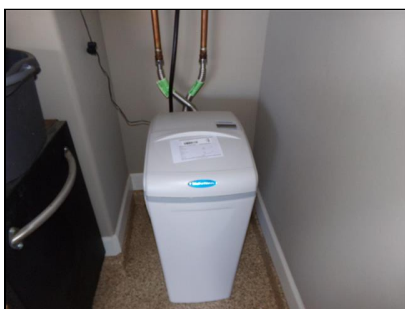
5.12 The water softener is low on salt. Water filters/softeners and any water filtration system units were not inspected since they are outside our scope of inspection. Recommend consulting the seller regarding the system's installation, maintenance history and operation. (CS) (M)

5.12 Item 1(Picture) Water Softner

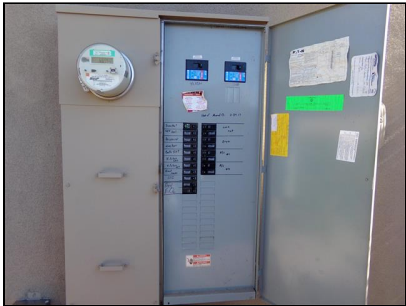
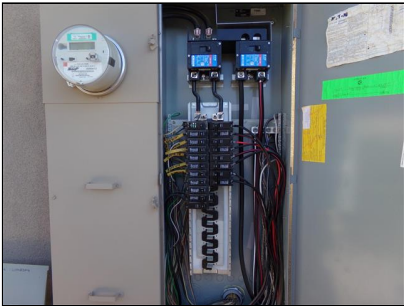
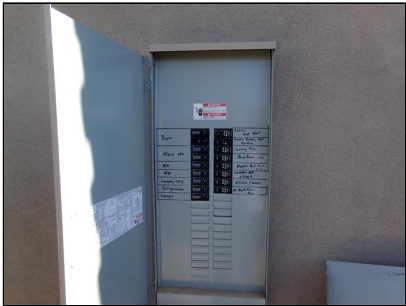
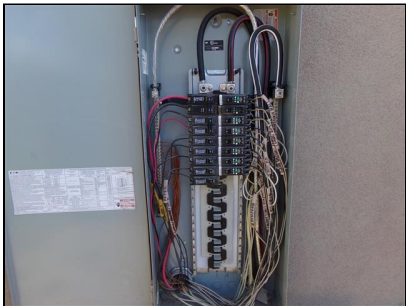
6.1 The main electrical panel was inspected. No deficiencies were found at the time of inspection. (CE) (M)

6.1 Item 1(Picture) Main Electrical Panel

6.1 Item 2(Picture) Main Electrical Panel - Interior

6.1 Item 3(Picture) Sub-Panel

6.1 Item 4(Picture) Sub-Panel Interior

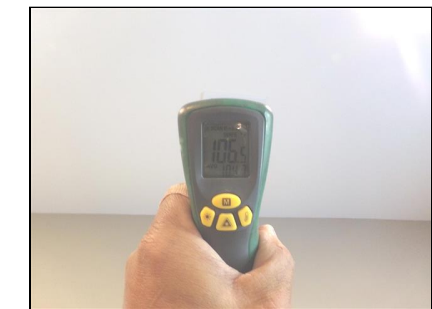
7.0 Item 1(Picture) Heat Temperature - Supply

7.0 The heating system was inspected and tested. It produced heat and operated properly at the time of inspection. (M)

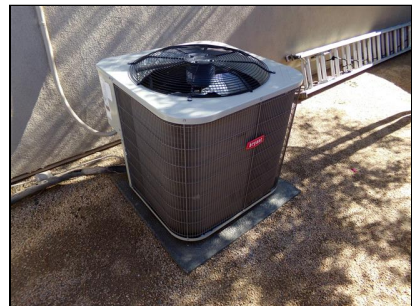
8.0 Item 1(Picture) Ground Mounted Condenser 1

8.0 The BRYANT Brand (R-410A Refrigerant) AC system operated and produced cool air at the time of the inspection. Recommend seasonal service, cleaning and further evaluation of the system by a qualified licensed HVAC contractor to insure that the unit is operating at its optimal condition. Home inspectors are not required to determine size, adequacy, age or efficiency of the HVAC systems. Recommend monitoring duct work and related connections for any signs of air leaks. Consult the seller for any past repairs or services done to the system. (CS) (M)

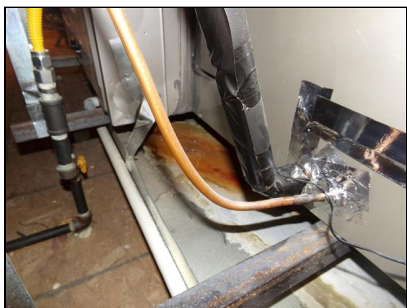
8.5 The condensate drain pan shows evidence of possible past plugged main drain. As a result, rusting stain was observed underneath the PVC overflow piping at the exterior of the structure and to the inside of the attic located overflow pan. Recommend having the overflow pan cleaned and serviced by a licensed HVAC contractor. (CS) (RR) (CE)

8.5 Item 1(Picture) Rusted
Condensate Pan

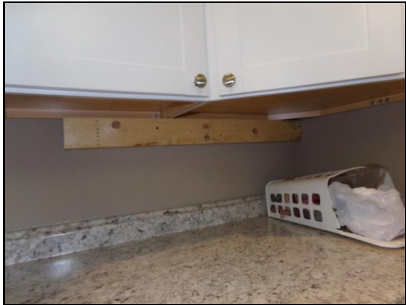
9.1 Item 1(Picture) Remove 2x4

9.1 Remove setting 2x4 under the cabinet. Repair wall if necessary after removal. (RR)

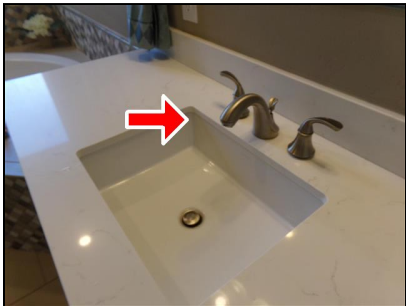
10.7 Item 1(Picture) Loose Faucet

10.7 Secure loose faucet assembly at master sink for proper operation. (RR)

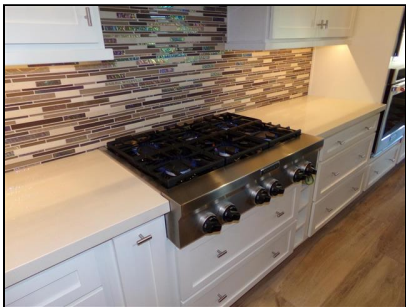
11.9 Item 1(Picture) Stove - Functioning

11.9 Kitchen Appliances operated properly. No deficiencies found at the time of inspection. (M)

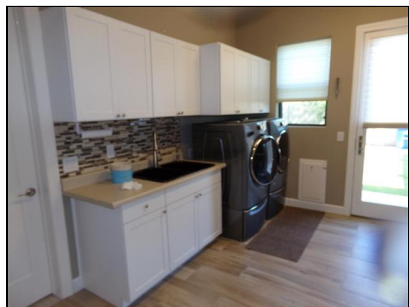
12.0 Item 1(Picture) Laundry Facility

12.0 Washer and dryer are outside our scope of inspection. Our inspection covers power and water supply to the appliances. No deficiencies found at the time of inspection. (M)

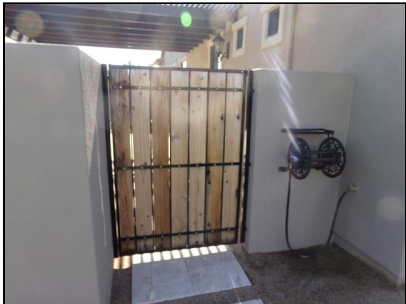
The side gate does not self close or latches. Recommend repairing/replacing in order to prevent a possible safety aspect (RR) (SA)

13.0 Item 1(Picture) Gate Needs Self Closing mechanism

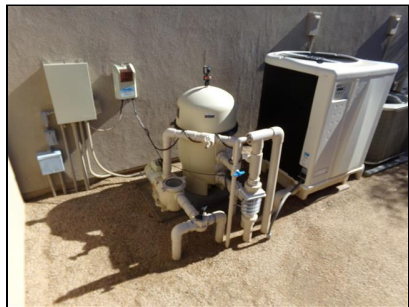
13.4 Item 1(Picture) Pool Valves and Equipment

13.4 The pool has a fabric type cartridge style water filter. Recommend monitoring the pressure for proper operation of the system. Replace filters as a regular maintenance routine for optimal operation of the filtration system. Recommend further evaluation by a qualified licensed pool contractor for solutions and repairs. (CE)

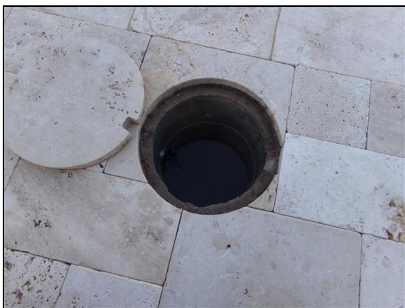
13.5 The pool water level auto fill device is not operational or missing. Evaluate Recommend further evaluation by a qualified licensed pool contractor for recommendations on operation and maintenance. (CE)

13.5 Item 2(Picture) Auto-Fill missing Float

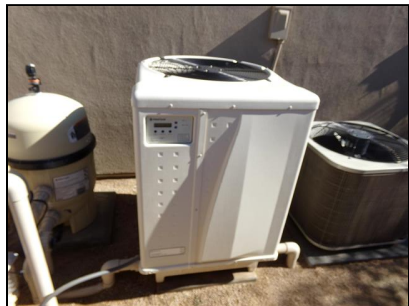
13.9 Item 1(Picture) Pool Heater

13.9 The pool heated was engaged from the main pool panel and it operated properly at the time of inspection. Recommend annual cleaning and servicing for optimal operation. (RR) (CE) (M)
