# ENTIRE VALLEY HOME INSPECTION

## HOME INSPECTION REPORT

1234 Main Street  
Queen Creek, AZ 85142

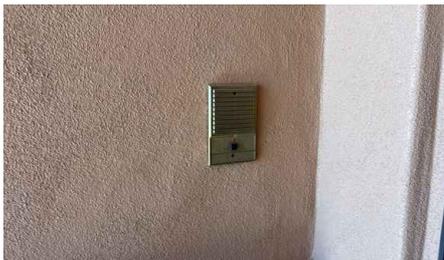
#### Doorbell: Satisfactory

The doorbell is functional and works on demand.

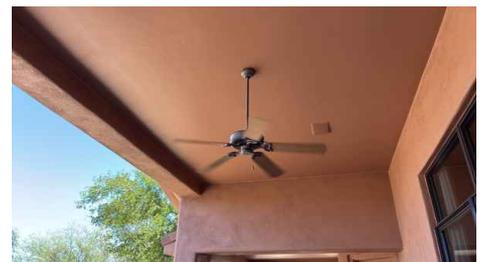
**Ceiling Fans: Patio Fans / Functional**

The patio fans that were tested are functional and respond on demand.

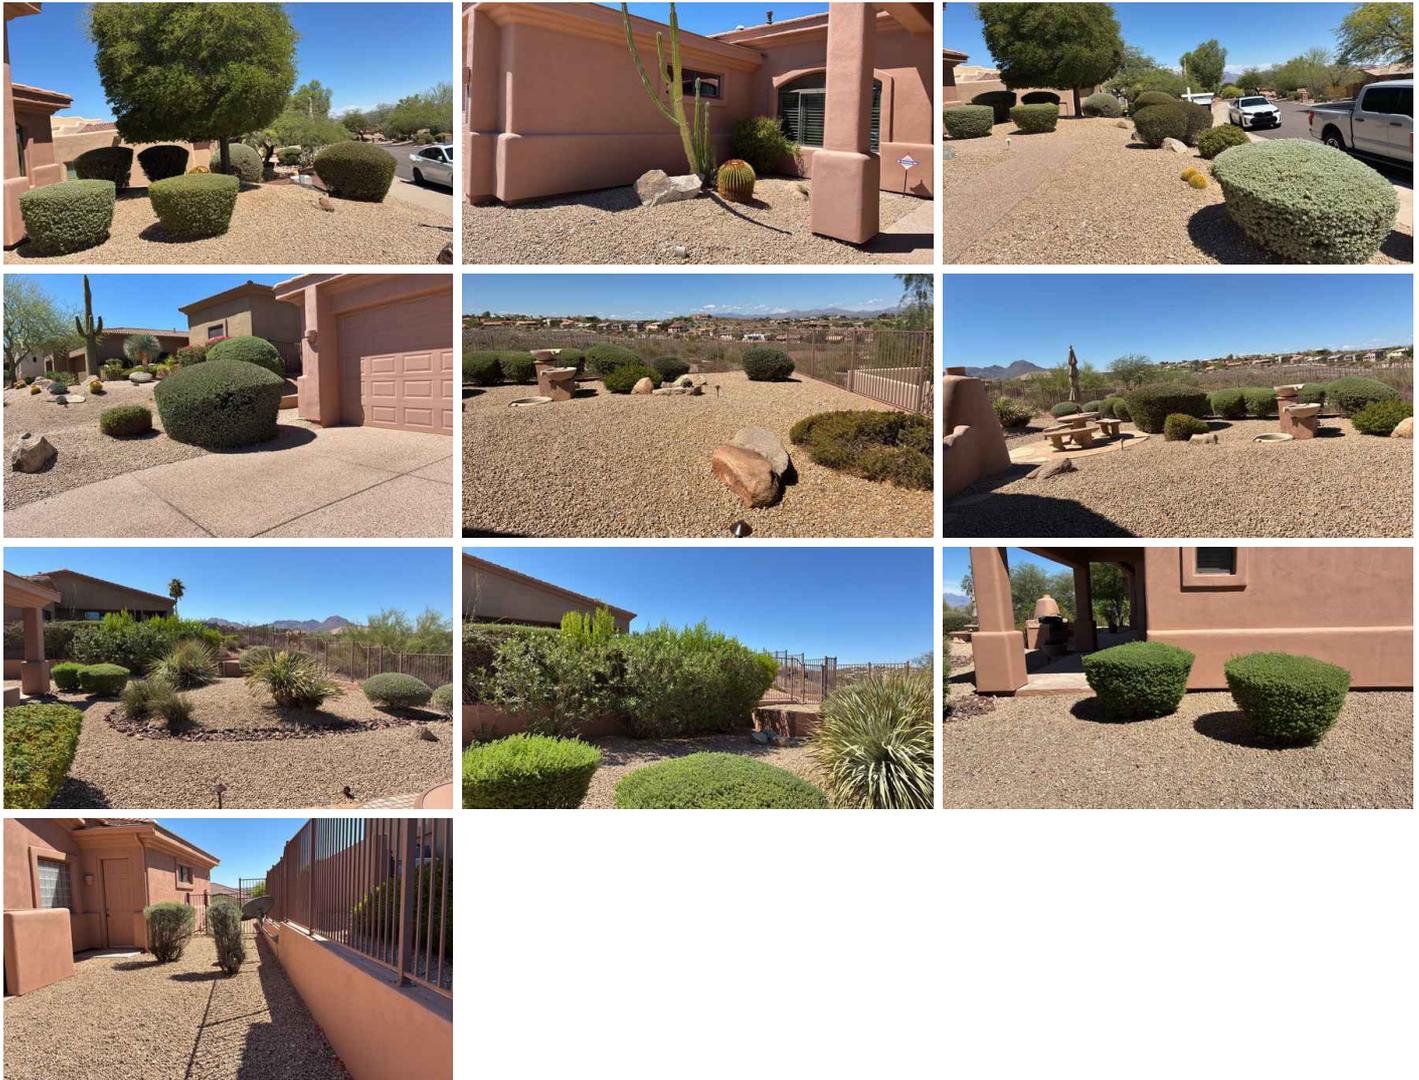
**House Wall Finish/Cladding: Typical Cracking Noted**

There are typical shrinkage or settlement type cracks observed in the stucco or block, which you should view for yourself. All cracks result from movement, and are structural in that respect, but the vast majority of them have only a cosmetic significance. Most people do not realize that structures move, but they do and sometimes more or less continuously. Therefore, stress, settlement or shrinkage type fractures can reappear after they have been repaired, and particularly if they have not been repaired correctly. I recommend that all exterior cracks and gaps, if present, are properly covered or sealed to help prevent possible moisture or pest intrusion. However, you may wish to have this confirmed by an appropriate specialist. Most stucco homes are recommended to be repainted about every 10 years or so.

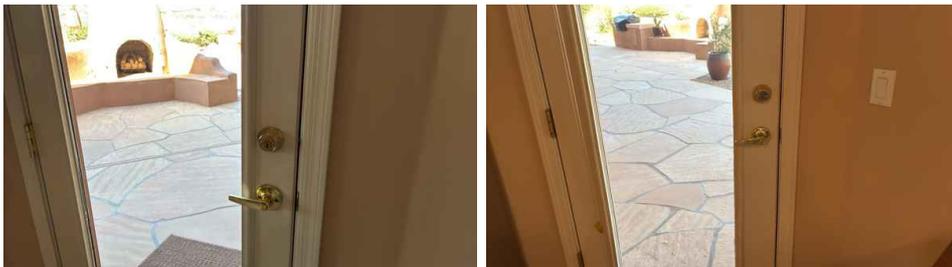
### KEYED DEADBOLT / RECOMMEND REPLACEMENT

The door(s) have a keyed deadbolt that could prevent or impede an emergency exit. This deadbolt should be replaced with a safer latch type.

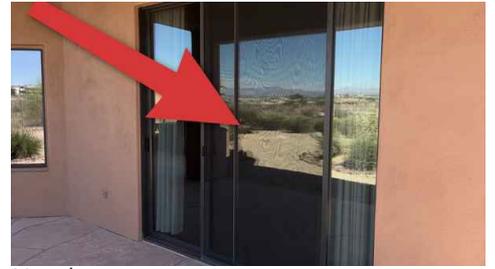
The backyard sliding glass door is difficult to operate and does not open smoothly or easily. I recommend further evaluation from a qualified contractor for service as determined necessary.

Recommendation

Contact a qualified professional.

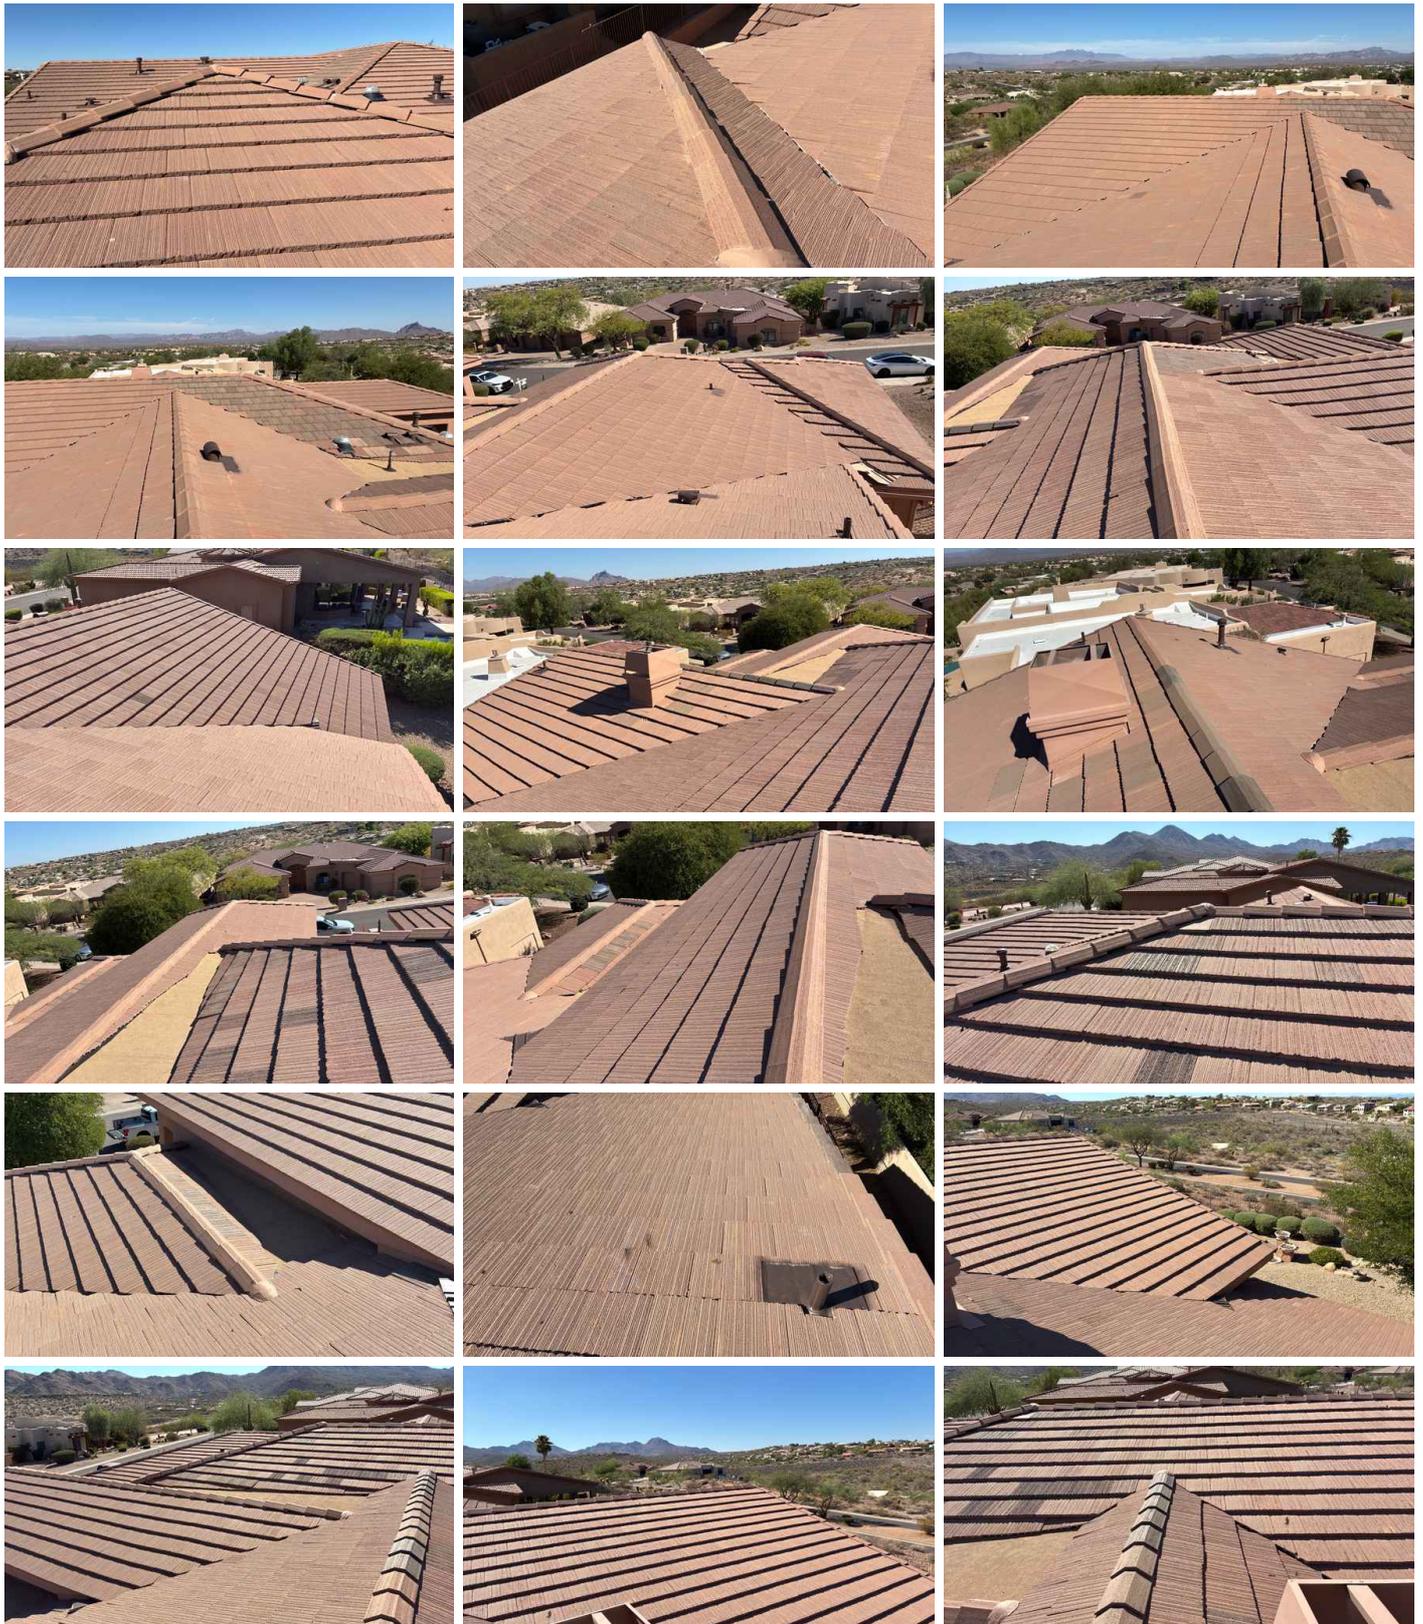
Main Roof Covering

**Flashings & Penetrations: Satisfactory**

The roof flashings are in acceptable condition where viewed, unless otherwise specifically noted. They appear to consist of metal flashing around roof penetrations and in valleys.

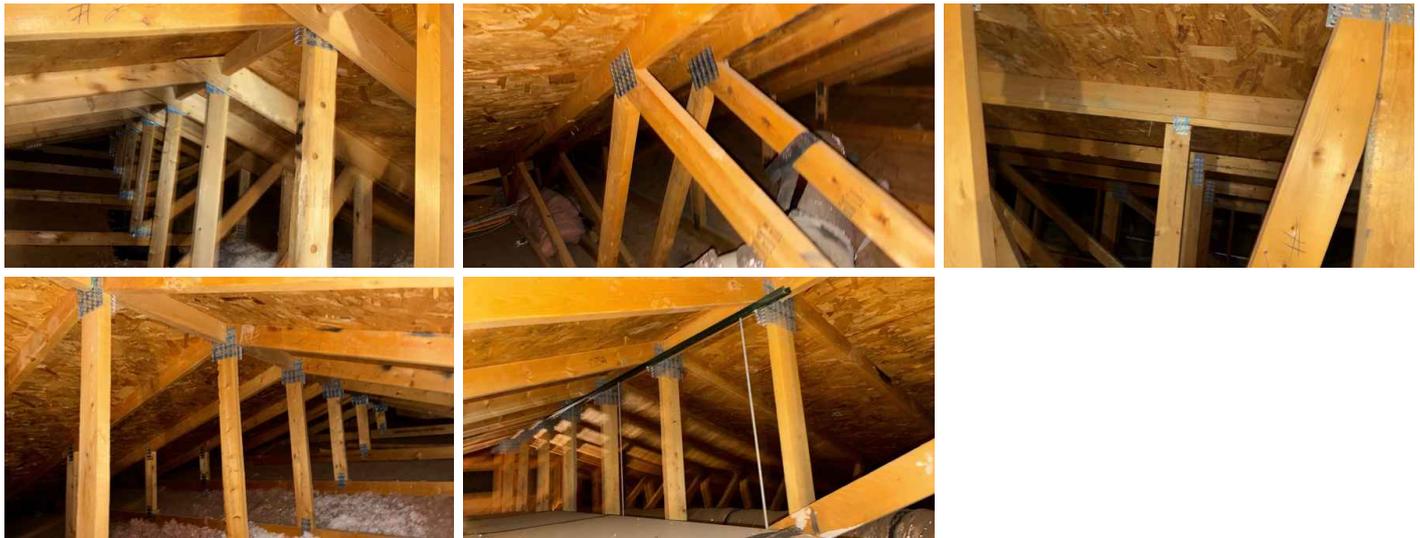
**Framing: Type**

Wood

**Framing: Factory Wood Truss / Satisfactory**

The visible wood roof framing is in satisfactory condition. The roof framing consists of a factory- built wood truss system, comprised of components called chords, webs, and struts that are connected by metal gussets nailed in place. Each component of the truss is designed for a specific purpose, and cannot be removed or modified without compromising the integrity of the entire truss. The lowest component, which is called the chord and to which the ceiling is attached, can move by thermal expansion and contraction and cause creaking sounds, which are more pronounced in the mornings and evenings along with temperature changes. Such movement has no structural significance, but can result in small cracks or divots in the drywall or plaster.

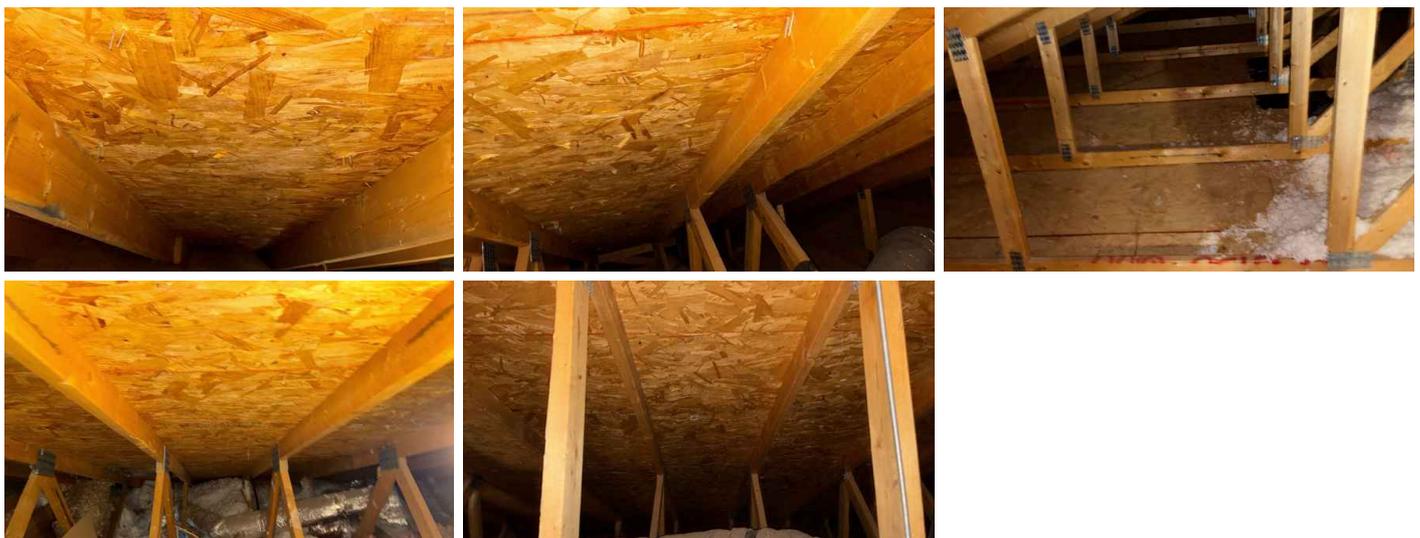
**Roof Decking/Sheathing: Decking / Sheathing Pictures**

**Roof Decking/Sheathing: Satisfactory**

The visible portions of the wood roof decking are in acceptable condition, unless otherwise specifically noted, and should conform to the standards of the year in which they were installed.

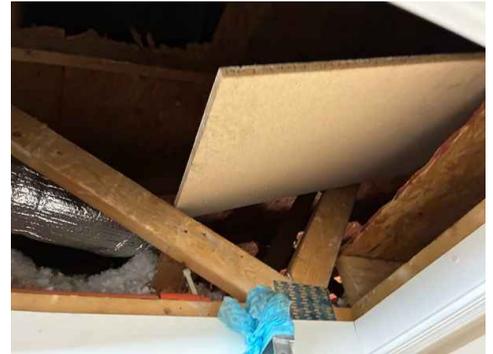
Master bathroom closet

5.3.2 Common Observations

Unsatisfactory Item

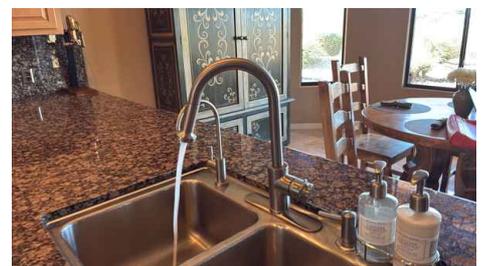
**Sink and Faucet: Picture / Water Flow**

Picture of the functional water flow at the kitchen sink.

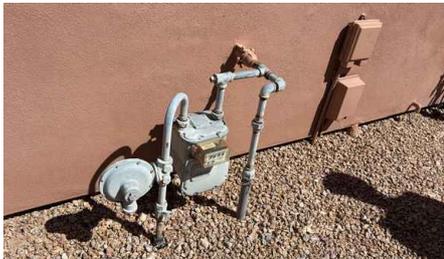
#### General Gas Components: Picture

Picture of gas main/meter.

Gas was on

The gas main/meter supply is either on or off as noted.

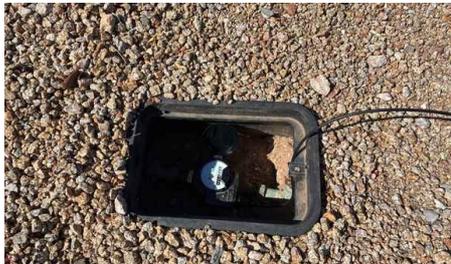
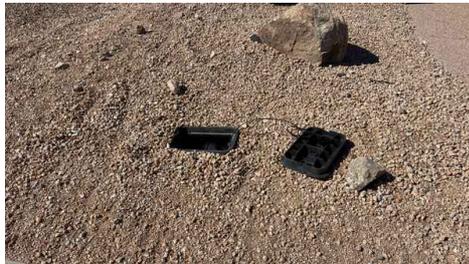
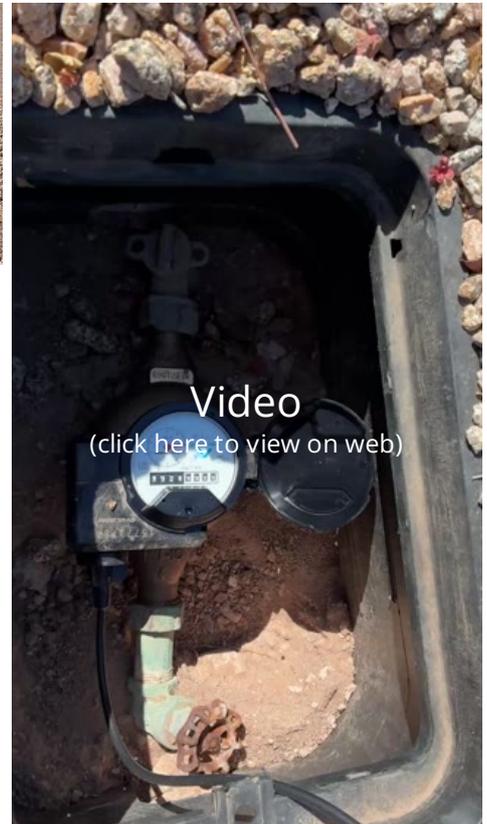
**City Water Meter: City Water Meter-Picture**

**City Water Meter: City Water Meter / Satisfactory**

The street or city water meter was observed for a short while, while no water was running on the property. The meter or dial was not spinning or moving, or the digital display reads 0.00. This is a good indication of no water leaking underground between the water meter and residence. However, this is not an exact determination and further evaluation may be necessary if you desire more detailed information or are concerned about the possibility of an underground water leak. Following up with the water company is a good idea so you are aware of potential normal water usage at this residence. I recommend getting an emergency water or plumbers key from a hardware store in case of emergency so you can easy shut off this meter if needed.

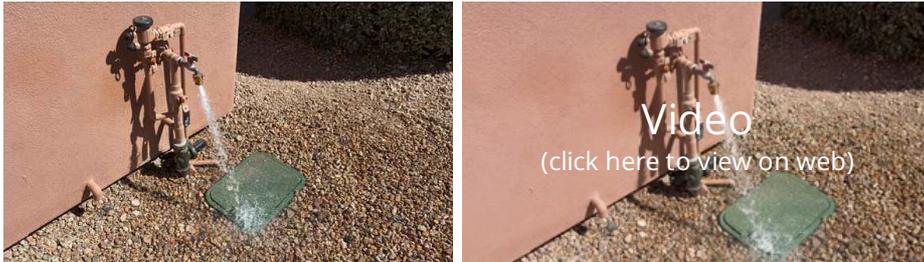
**Water Supply Pressure: Functional Water Flow**

Functional Water Flow Was Noted

**Satisfactory / Functional Flow**

The water supply plumbing lines for this residence appear to be in satisfactory condition, where visible. Functional water flow was verified. Unless otherwise indicated.

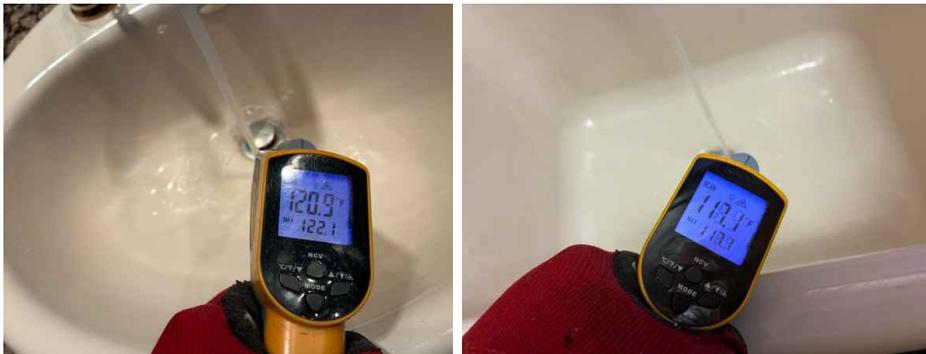
### Gas Hot Water Heater: Hot Water Temperature Noted

116 - 120, 121 - 125

The residence hot water heater water temperature was noted as satisfactory during the home inspection. Hot water temperature supply was verified at all sinks, tubs, showers etc; unless otherwise noted. The hot water temperature is recommended to be set at a minimum of 110 degrees Fahrenheit to kill microbes and a maximum of 140 degrees Fahrenheit to prevent scalding. Hot water temperature can also be raised or lowered as desired at the water heater.

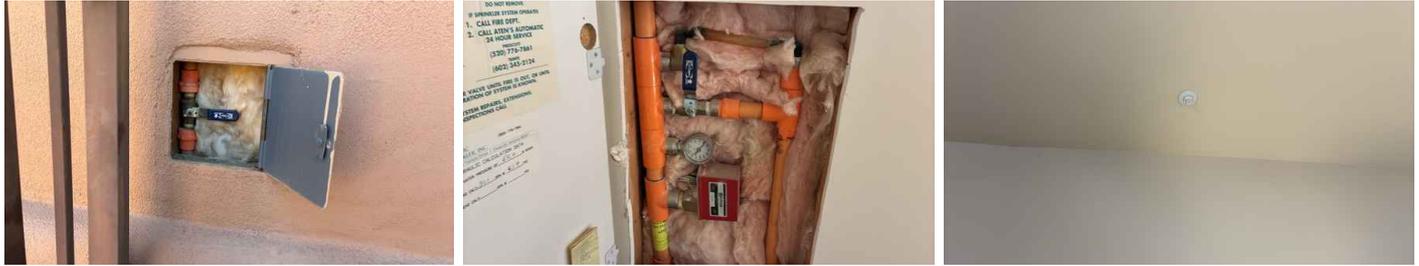
### Fire Suppression System: Location

Interior

### Fire Suppression System: Comment / Onsite

The residence is equipped with fire sprinklers, which I am not qualified to evaluate and specifically disclaim in our contract. These systems require annual maintenance and upkeep just like any other plumbing system will. Typical and acceptable fire sprinkler system water pressure is 50 psi to 150 psi. Therefore, you are recommended to have the system properly evaluated by a qualified fire sprinkler contractor or the local fire department as necessary and certified as being functional as an important fire safety feature. However, there were no signs of active leaking noted.

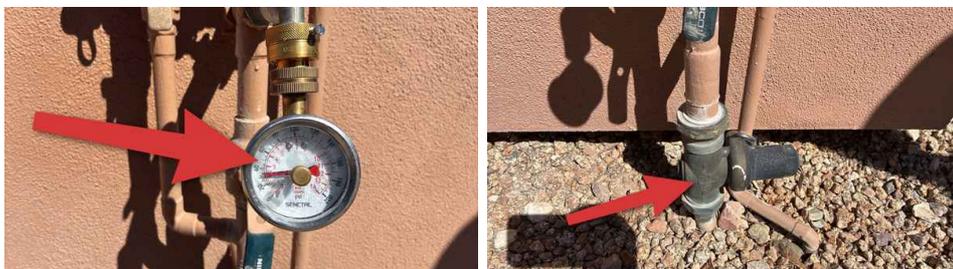
Adjust the water pressure on the pressure reduce in valve in order to increase it to a minimum of 45 to 60 psi. Consult a licensed plumber for further evaluation and repairs. The water pressure is currently 38 psi.

Recommendation

Contact a qualified professional.

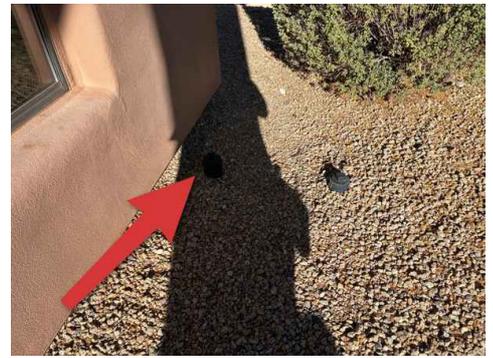
9.6.1 General Gas Components

**OLD AND WORN GAS METER**

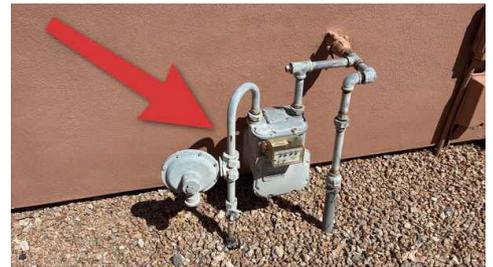
9.7.1 Gas Hot Water Heater

**SEDIMENT TRAP**

The gas supply line for this water heater does not include a drip loop, drip leg or sediment trap. One of these items is currently recommended to be added as a modern safety feature. Further evaluation is recommended from a qualified contractor to determine the level of service necessary.

Recommendation

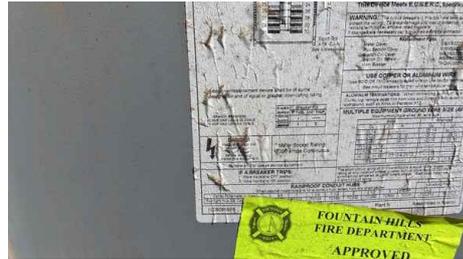
### Main Panel Observations: Condition

Main Panel  
Satisfactory

**Main Panel Observations: Satisfactory**

The main electrical breaker panel and its components have no visible deficiencies, unless otherwise specifically noted.

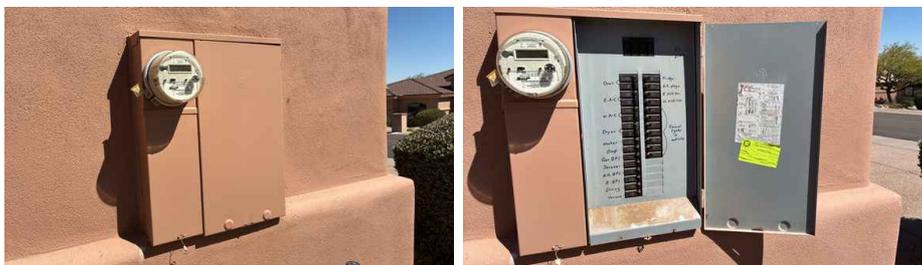
### Panel Size & Location: Picture / Manufacturer Label

### Panel Size & Location: Panel Amperage as Noted On Label

200 Amp; 120/240 Volt

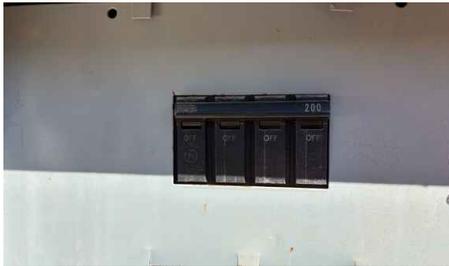
200 Amp; 120/240 Volt

Size of the visible installed main breaker. Specialized testing equipment was not used to verify this.

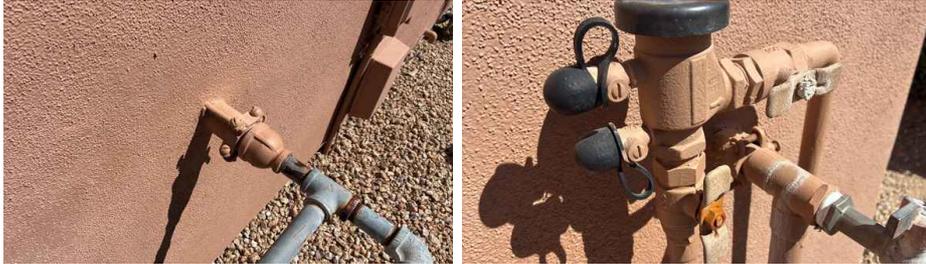
**Grounding: Grounding Location**

Gas Main Meter, Main Hose Bib

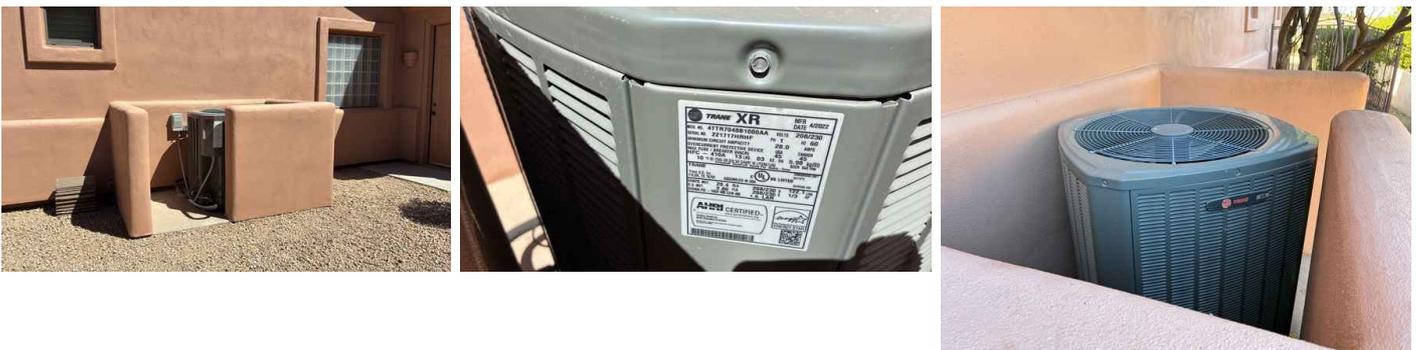
### Condensing Coils Age/Data/Comments: Picture and Data Plates (ALL)

**Condensing Coils Age/Data/Comments: Satisfactory**

The condensing coil(s) respond to the thermostat and are functional, unless otherwise specifically noted.

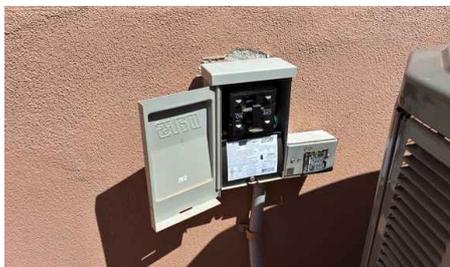
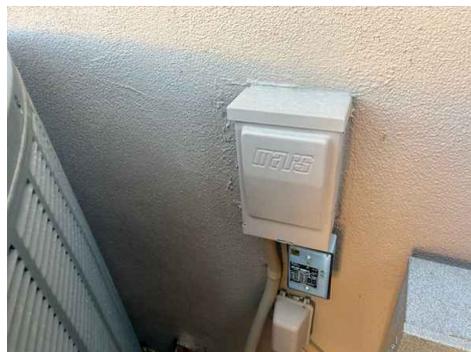
Pull Out

Type of disconnect noted.

**Condensing Coil Disconnect: Not Tested**

The electrical disconnect(s) at the condensing coils are present and appear functional; however they were not activated or tested at the time of inspection.

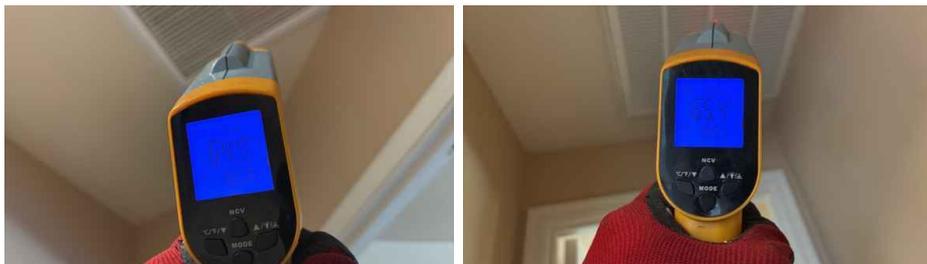
65

Air return temperatures in degrees Fahrenheit for this residence were as noted.

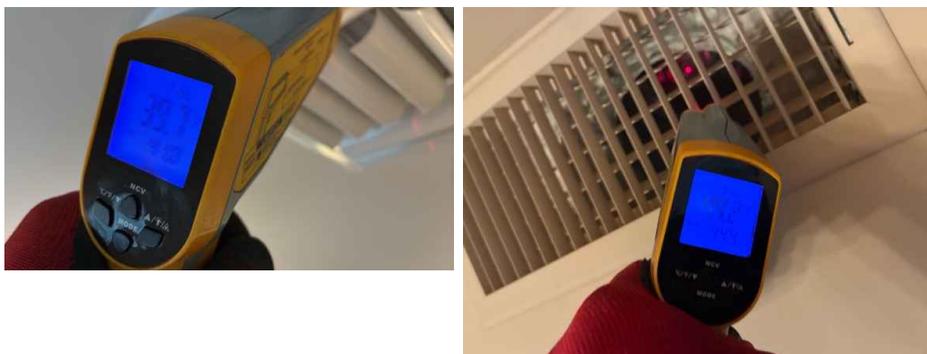
**Cooling Temperature Readings: Air Supply Temperatures / As Noted**

Air Supply Registers

40, 44

Air supply temperatures in degrees Fahrenheit for this residence were as noted.

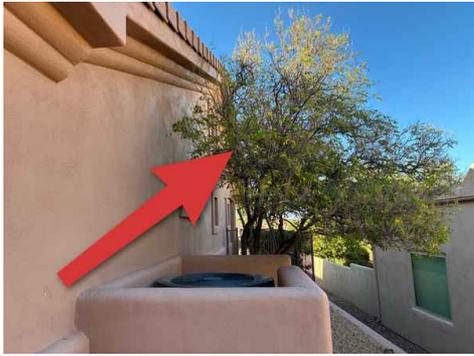
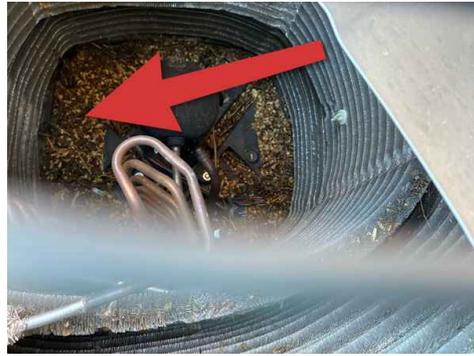
11.8.1 Condensing Coil Disconnect

**LOOSE ON WALL**

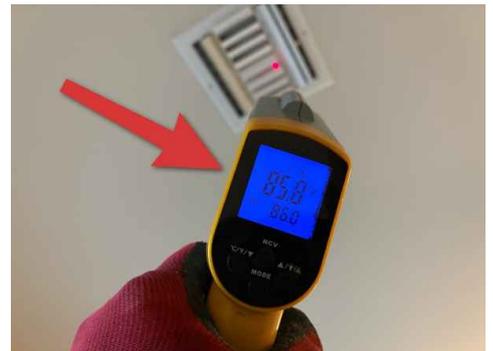
11.12.2 Heating Temperature Readings

**GAS OFF / UNABLE TO TEST**

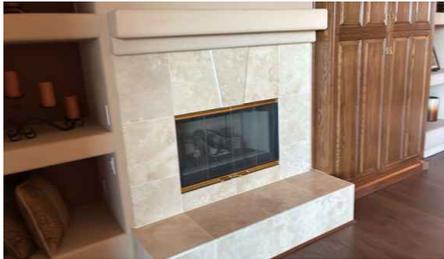
**Fireplace Type & General Comments: Location & Pictures**  
Family Room

**Chimney Walls: Satisfactory**  
The chimney walls appear to be in satisfactory condition.

**Weather Cap-Spark Arrestor: Satisfactory**  
The chimney(s) have a functional weather cap/spark arrestor.

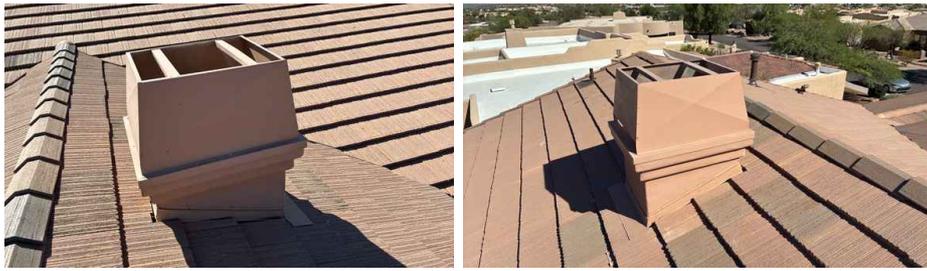
### Chimney Walls: Condition

Visible

### Chimney Flashings: Satisfactory

The chimney flashings appear to be in acceptable condition, unless specifically noted otherwise.

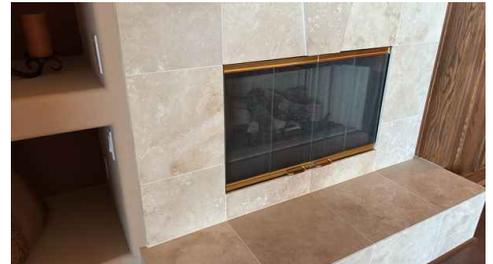
12.1.2 Fireplace Type & General Comments

### REPLACE MISSING GAS KEY

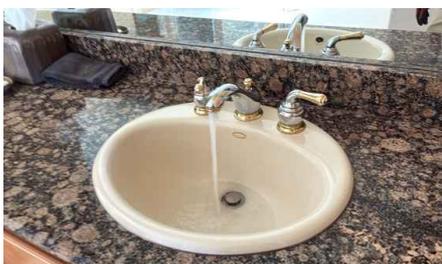
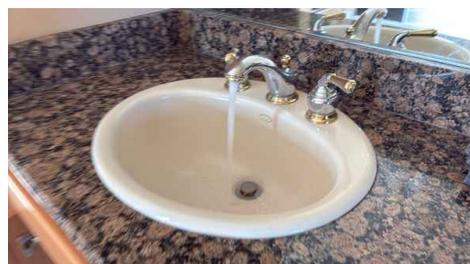
Pictures of functional water flow at the residence bathroom sinks.

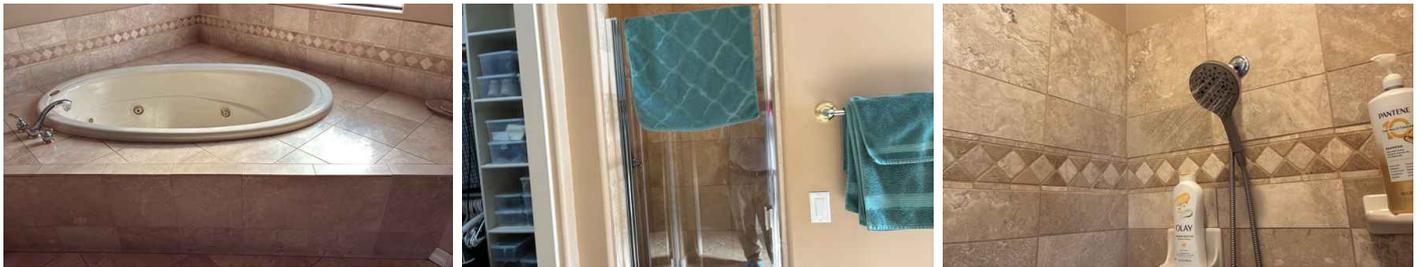
Separate Stall Shower, Separate Tub

Type of tub and/or shower noted in this bathroom. Water flow pictures.

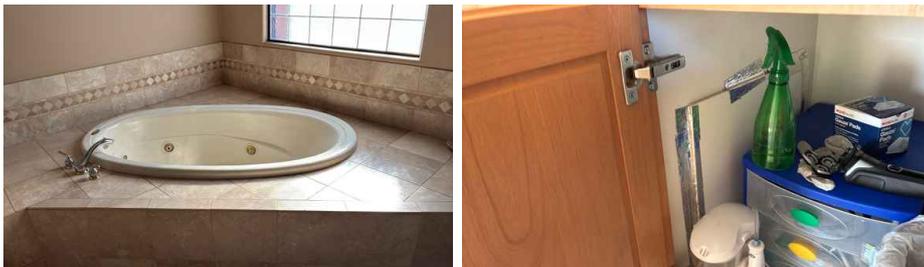
Works on Demand

The master bathroom hydro-spa tub is functional and the motor responds on demand. It should be flushed with a cleanser if not used frequently.

The grounding connection for the whirlpool tub motor was not visible during the inspection. I recommend having it verified before using this tub.

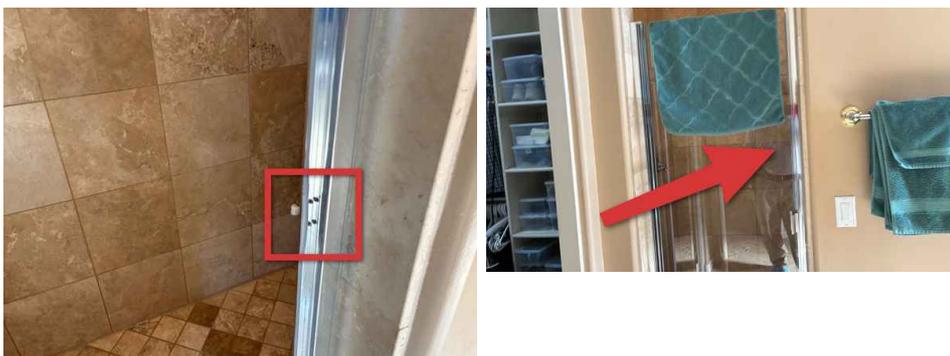
The master bathroom door does not latch shut and hold closed. I recommend service as you feel necessary.

Recommendation

Contact a qualified professional.

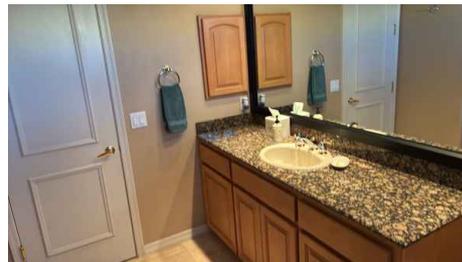
Pictures of water flow during the inspection.

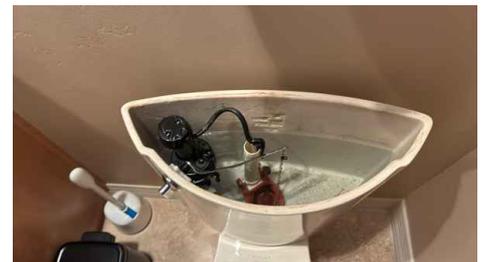
Flushes on Demand

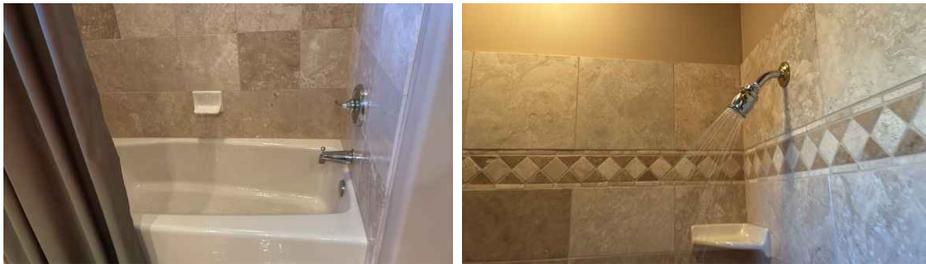
Tub &amp; Shower in One

Type of tub and/or shower noted in this bathroom. Water flow pictures.

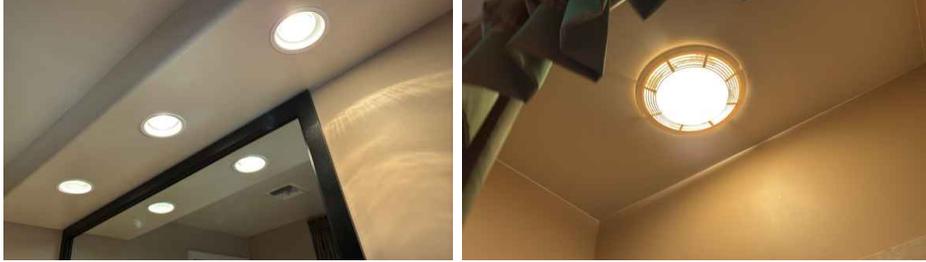
Ceiling Lights, Wall Lights

Type of lighting installed.
